**PHASE I ENVIRONMENTAL ASSESSMENT  
WYLE LABORATORIES  
SCIENTIFIC SERVICES & SYSTEMS GROUP  
1841 HILLSIDE AVENUE  
NORCO, CALIFORNIA**

**O'Melveny & Myers  
610 Newport Center Drive  
Newport Beach, California 92660-6429**

**August 1994**

RE: Phase I Environmental Assessment of Wyle Laboratories, Scientific Services  
& Systems Group, 1841 Hillside Avenue, Norco, California  
BB&L Project Number: 01901.02

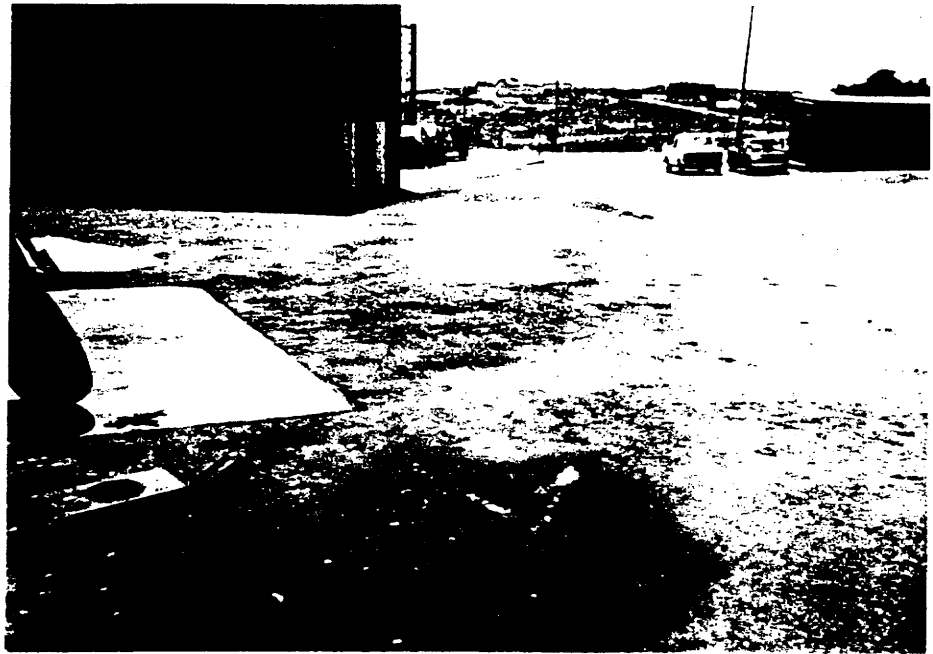
Photograph # 2-1

Staining of concrete and soil in the immediate vicinity of hydraulic equipment was observed at each of the test bays. The amount of staining varied from site to site. BB&L assumes that this local staining is the result of hydraulic oil releases. Wyle personnel refer to the oil by its trade name: Tellus Oil.

WYLE-NORCO	
ROLL/ PHOTO	PHOTO DESCRIPTIONS
2-1	Looking southwest from building F-10 toward LOCA building. Stained pavement from hydraulic oil releases.
2-2	Hydraulic shaker platform in building F-10.
2-3	View into equipment vault at building F-10 (poor quality image).
2-4	View from LOCA building across main road toward south showing area of oil staining.
2-5	Circular vault in nuclear test area looking toward the east.
2-6	Circular vault in nuclear test area looking toward the west. Photo also shows the nuclear test facility.
2-7	Hydraulic sump room at building F-2. Storm drain is to the left of the sump room and the test bay is to the right.
2-8	Hydraulic pump room at building F-2 showing oily floor. (Poor quality image).
2-9	View inside building F-3. (Poor image).
2-10	Hydraulic pump outside of building F-3 (?).
2-11	First photo of a two photo panorama of F-5 test chambers looking northwest.
2-12	Second photo of a two panorama of F-5 test chambers looking northwest.

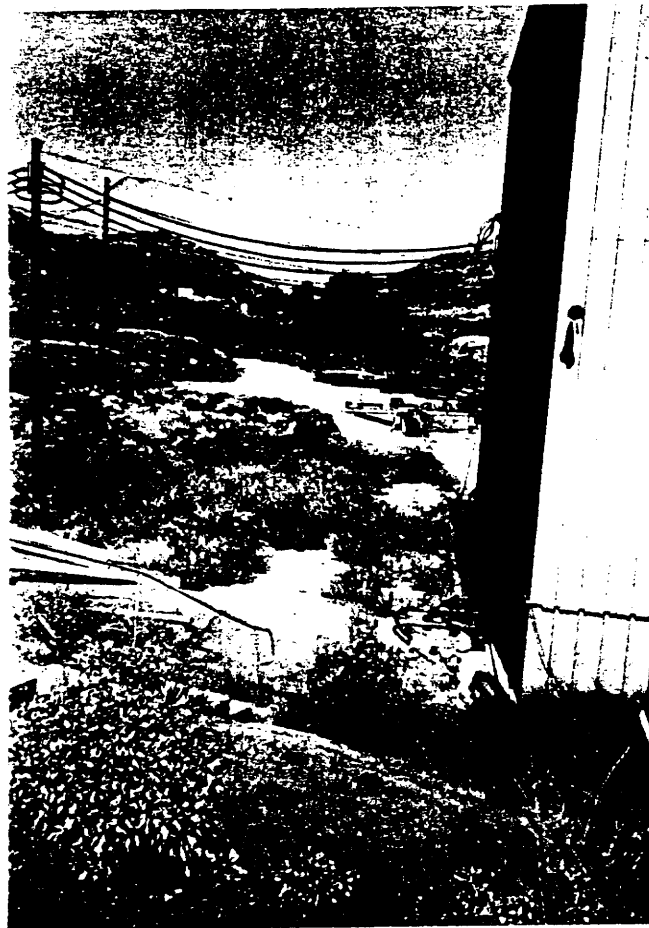
Photograph # 2-13

2-13	North side of MX building showing area where hydraulic pump had been positioned. View looking east toward J-15, rocket test site.
2-14	Centrifuge at J-9 looking south from top of berm.
2-15	Wyle sign at front gate.
2-16	Reported location of a Norco Battery.
